Visual Building Inspection Report

79 Camelia St, Cannon Hill

29/10/2024.

9434 b

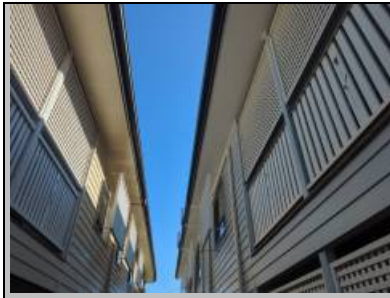
Appear to be in serviceable condition.

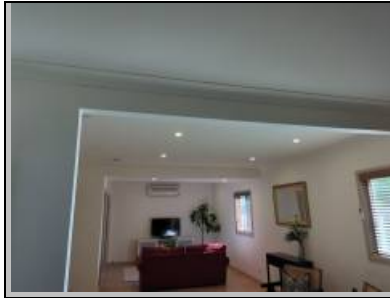
Various areas.

The condition of the ceilings is generally good. General wear and tear is noted. Minor settlement cracks were noted and these are typical of this type of material. Periodic maintenance may be required.

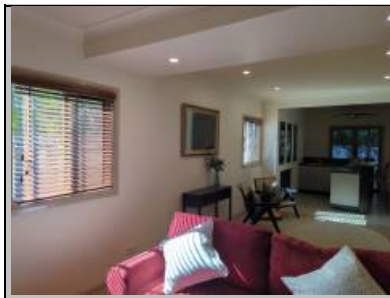
Various areas.

The condition of the walls is generally good. General wear and tear is noted. Minor cracking is evident to wall linings. Periodic maintenance may be required.

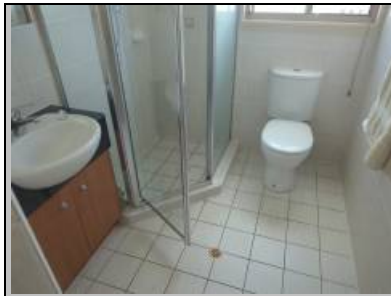
The condition of the fixtures is generally good. General wear and tear is noted.

Shower appears to be in a serviceable condition. Staining noted to grouting and silicone sealants, clean, re-grout and replace sealants as required.

Maintain all sealants and grouting to prevent moisture penetration and damage.

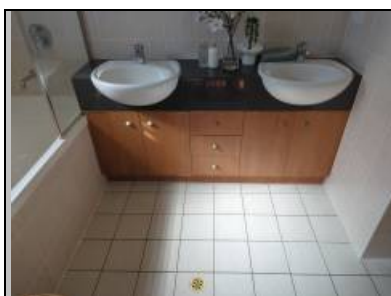
The condition of the fixtures is generally good. General wear and tear is noted.

The shower is located over the bathtub. The area will need to be kept well sealed to prevent water penetration to surrounding areas.

The basin & cabinets appear serviceable. The basin is cracked or damaged and requires replacement.

Maintain all sealants and grouting to prevent moisture penetration and damage.

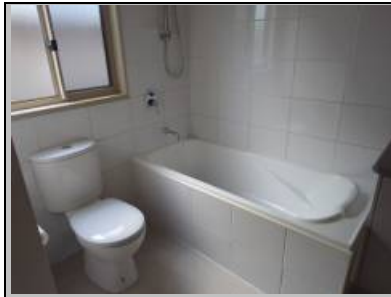
The condition of the fixtures is generally good. General wear and tear is noted.

The shower is located over the bathtub. The area will need to be kept well sealed to prevent water penetration to surrounding areas. A fixed shower screen should be installed.

Maintain all sealants and grouting to prevent moisture penetration and damage.

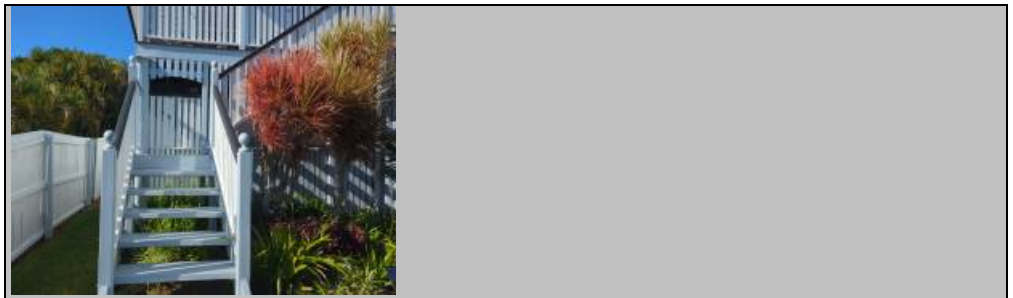
The stairs are constructed primarily from timber. The overall condition of the stairs is good. Minor Wood decay is noted.

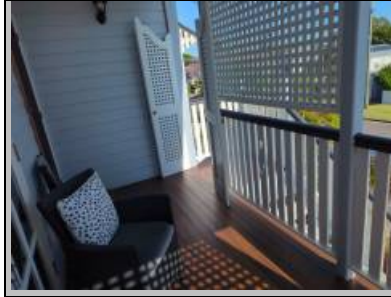
Front elevation:

Constructed from timber. The general condition of this structure is good.

Minor wood decay is present to the structure.

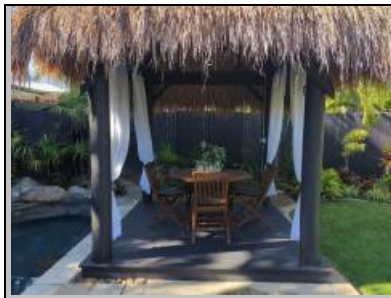
Rear elevation:

Constructed from timber. The general condition of this structure is good.

Minor wood decay is present to the structure.

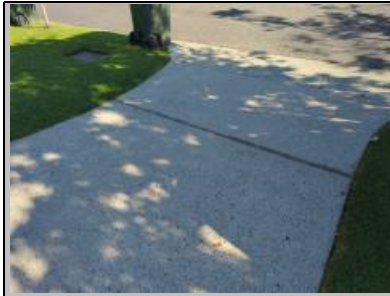
The concrete driveway stands in good condition. Minor concrete cracks are noted.

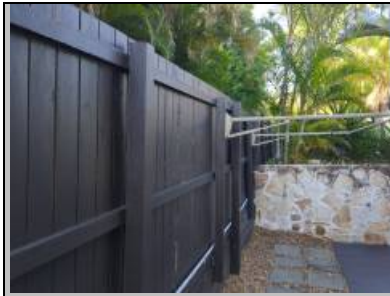
Dividing fence section:

The fences are mainly constructed from timber. The fences are generally in good condition. Minor wet rot or defects were noted to the wooden fences and minor repairs maybe needed.

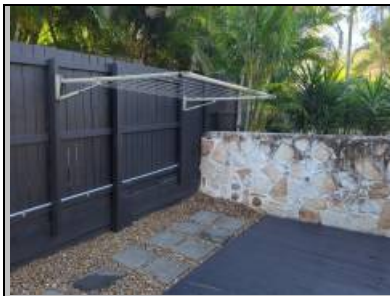
Various Elevations.

The timber retaining walls show normal deterioration and should be monitored. The masonry retaining walls show normal deterioration, cracks etc, and should be monitored for any movement.

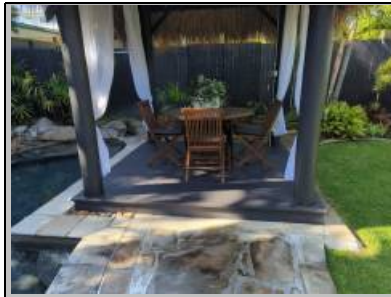
Yes - Fungal Decay (wood rot) was noted to the following timbers/areas.

Decking timbers: Steps/stair timbers: Sleepers or timber landscaping materials:

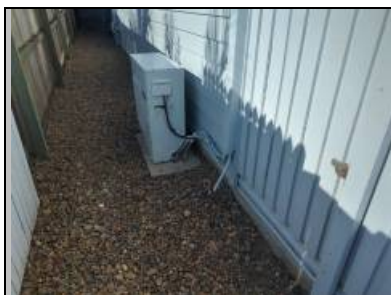
Garden beds have been built up against the external walls. These should be removed as they can allow concealed termite entry.

Some external timbers and cladding are in contact with soil. These should be modified so that timber to soil contact does not occur.
